Repairing TRITTON Kunai Right Speaker

This guide will walk you through repairing the right speaker on your headset if our troubleshooting page proved insufficient.

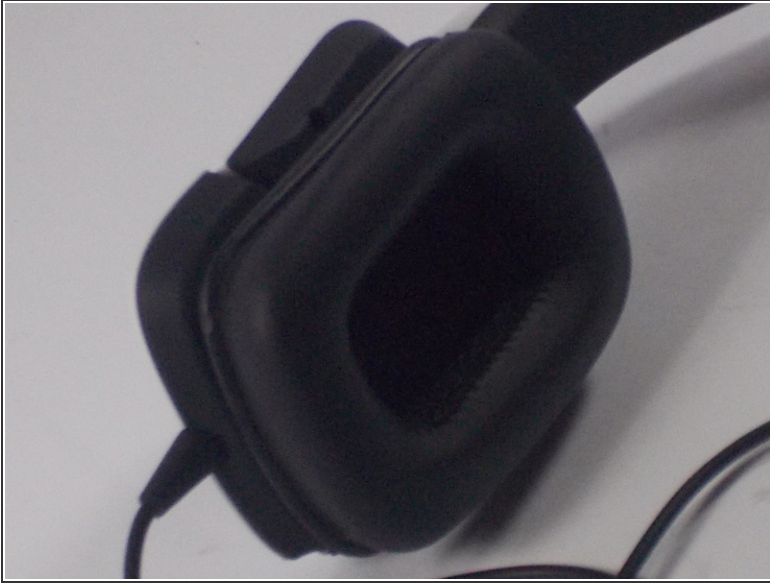
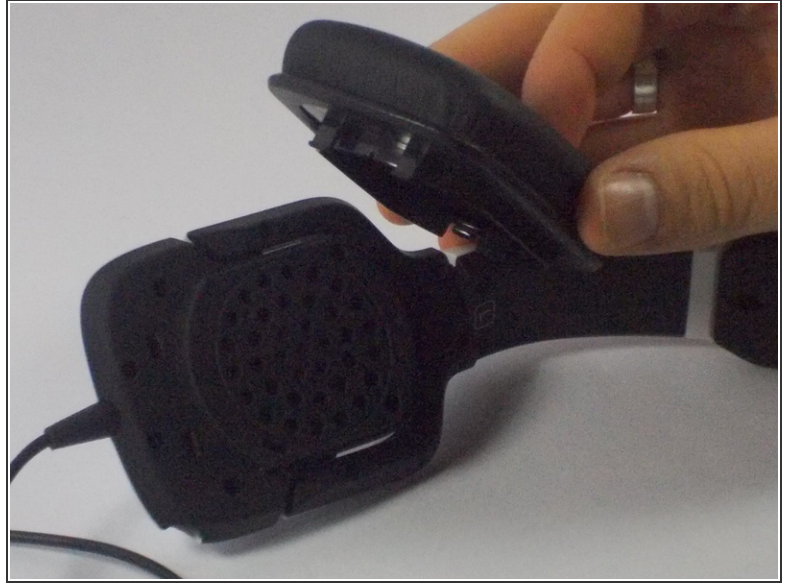
Step 1 — Repairing TRITTON Kunai Right Speaker

- Firmly grasp the black ear cushion with one hand and the white speaker frame with the other hand.
- Forcibly pull the ear cushion and speaker frame in opposite directions, until the right ear cushion separates from the right ear frame.

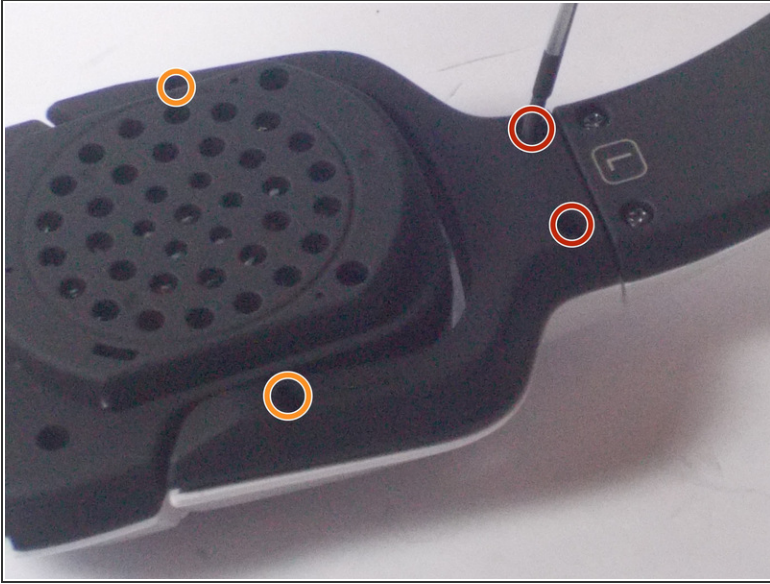
Step 2

- Remove the two 9 mm screws indicated in red with a PH00 screwdriver.
- Remove the two 7 mm screws indicated in orange with a PH00 screwdriver.
- Separate the black horseshoe shaped frame from the right speaker frame.

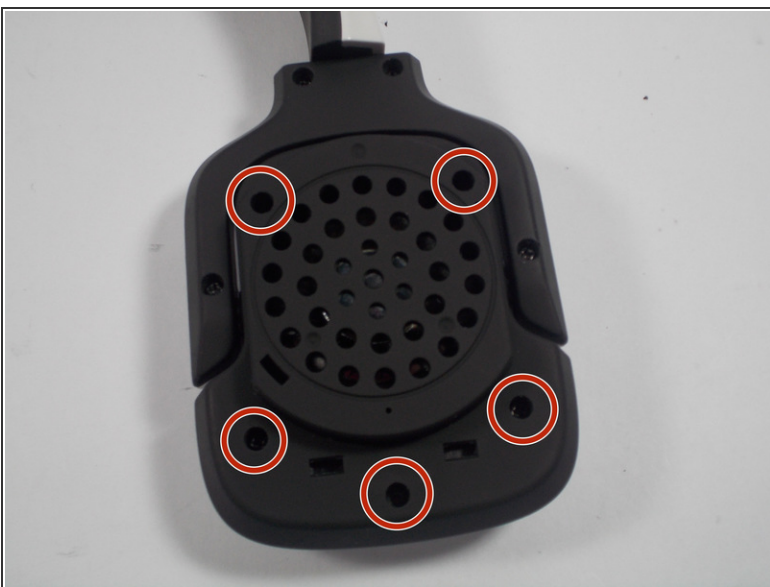
Step 4

- Remove the five 7 mm screws indicated in red using a PH00 screwdriver.
- Separate the black speaker console from the right speaker frame.

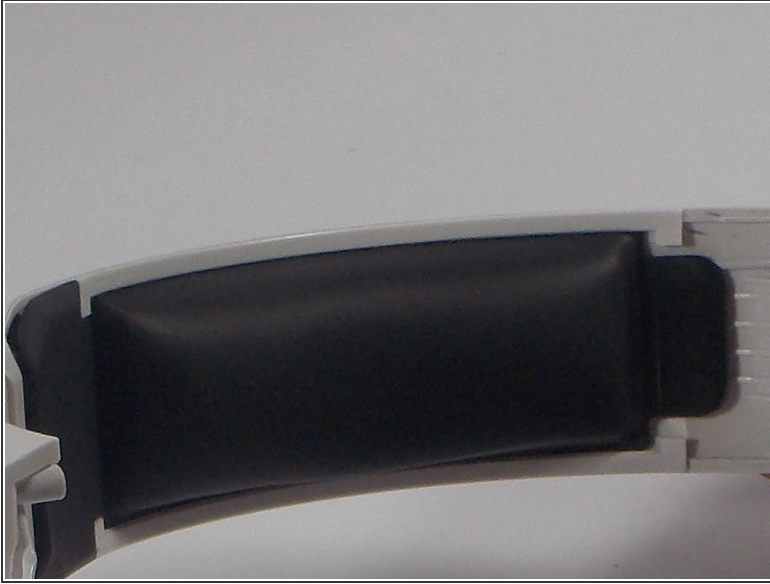
Step 10

- Firmly grasp the black head cushion with one hand and the white rail adjustment with your other hand.
- Forcibly pull the cushion and rail adjustment in opposite directions until the cushion is completely disconnected.
